A fire resistance test  
performed on a single leaf,  
single acting steel access  
panel test conducted in  
accordance with BSEN 1634-  
1: 2008 and BSEN 1363-1:  
1999

Chilt/RF13137 Revision E

Fire Proofing Services Ltd

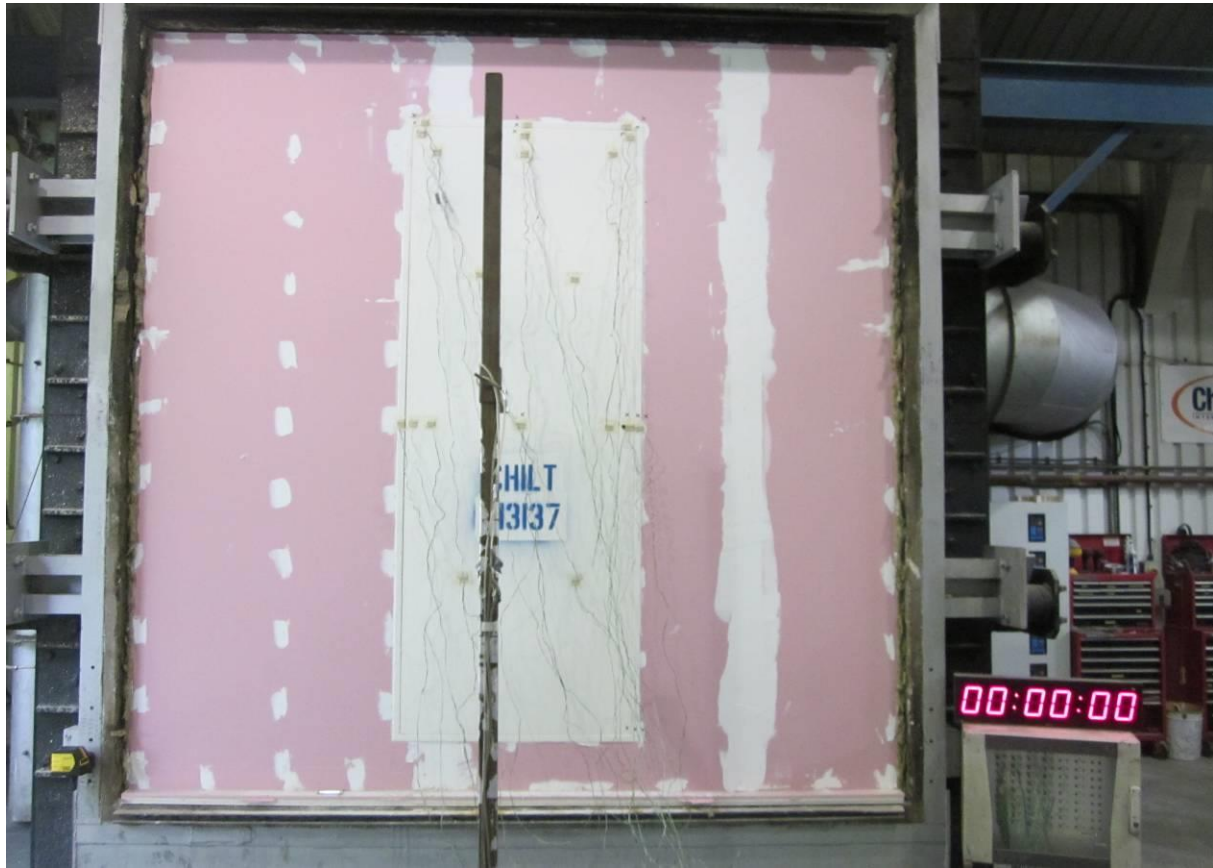
At start of test

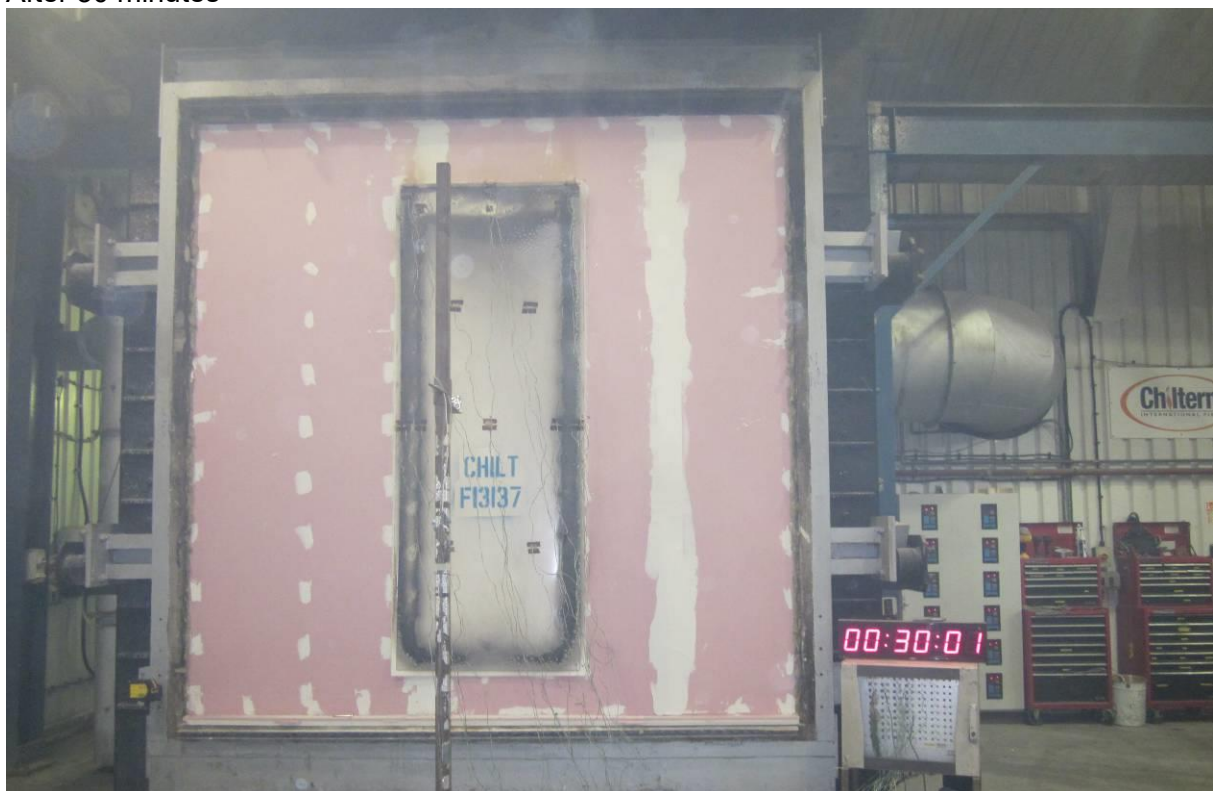
After 30 minutes

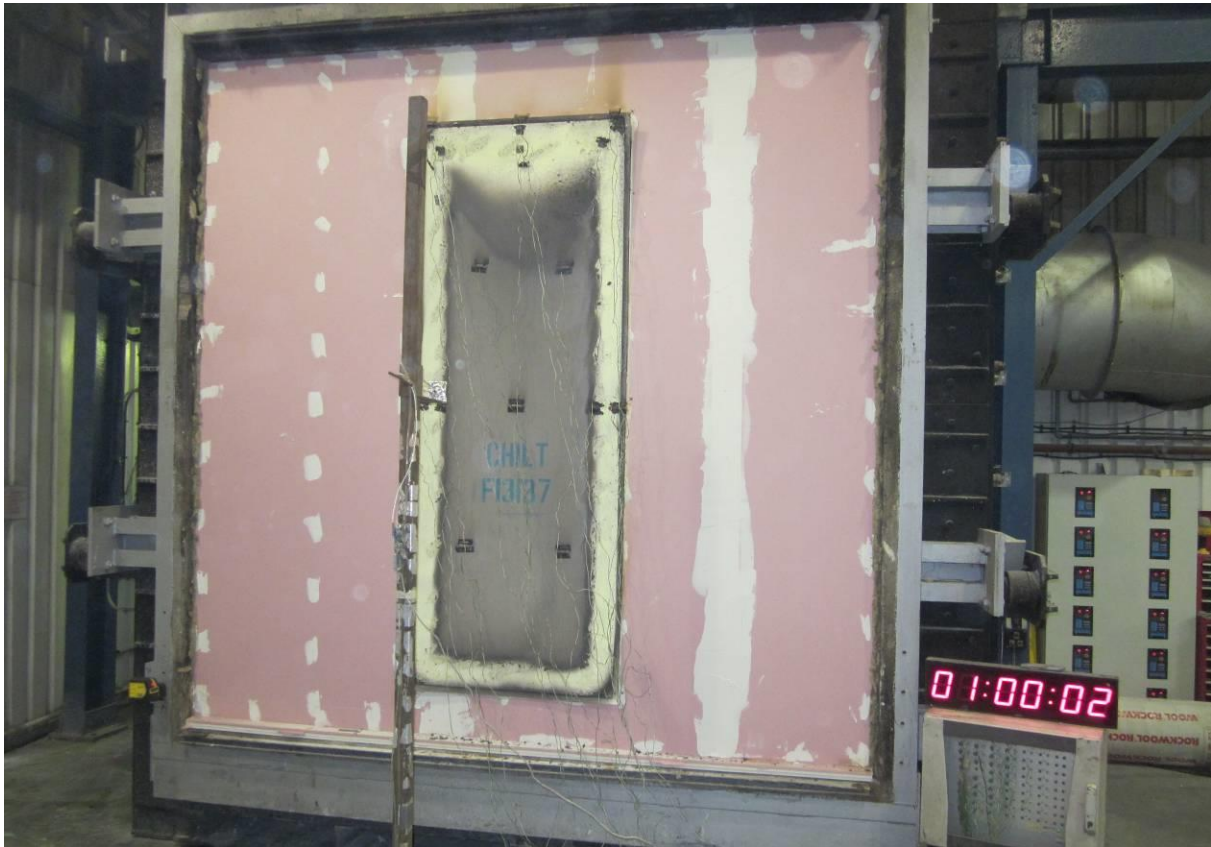
After 60 minutes

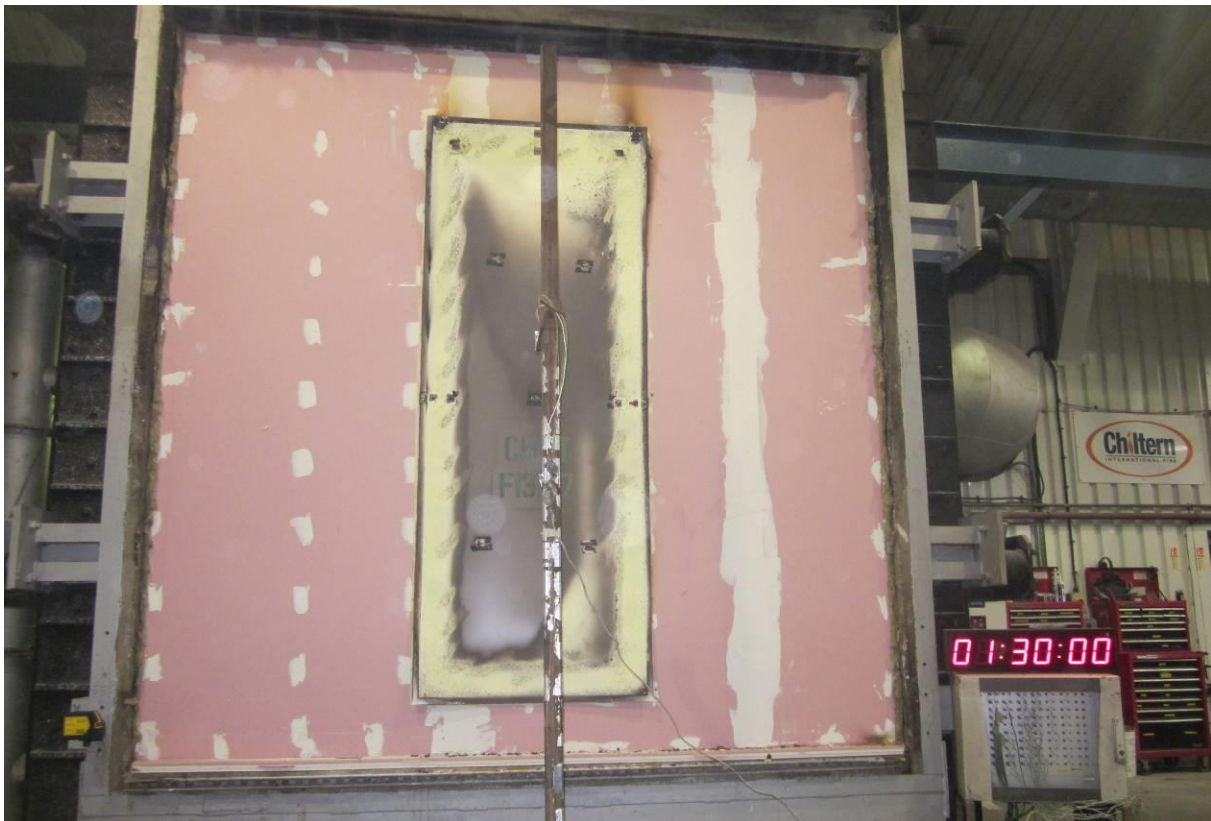
- 89.30 The crack in the plasterboard on the exposed face has now opened to approximately 20-25mm.
- 92.00 The exposed face plasterboard has fallen away.

At 90 minutes

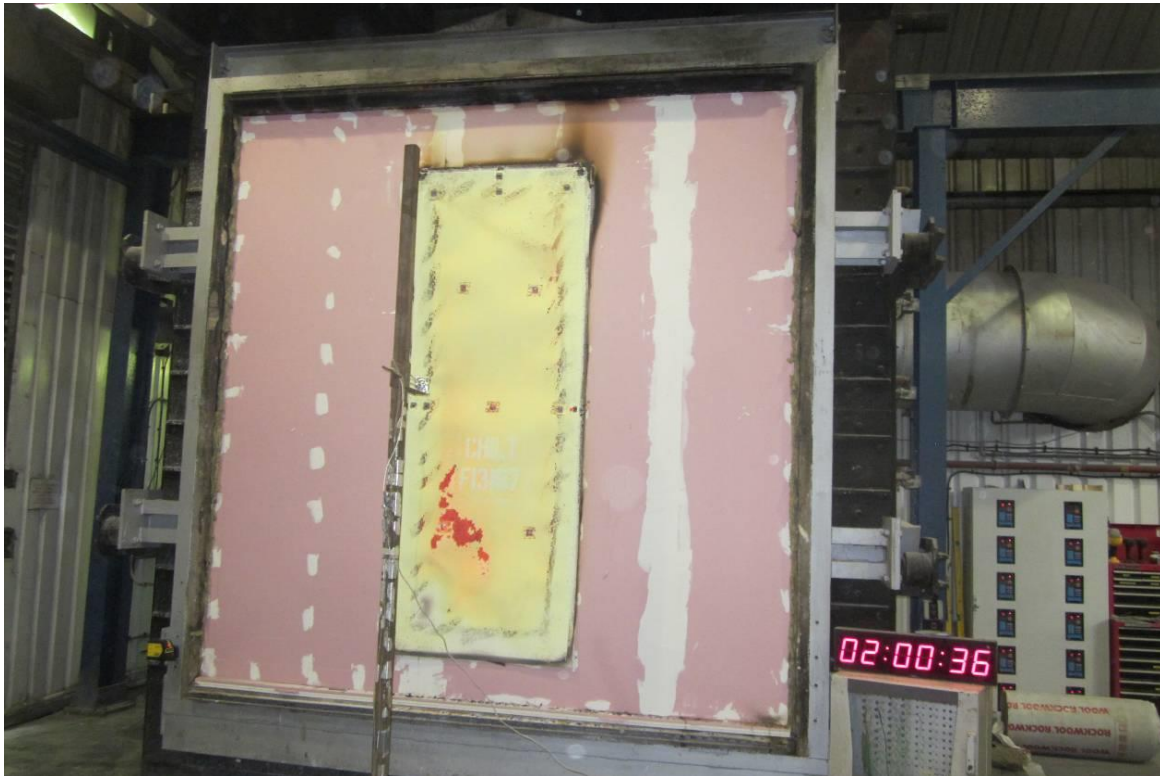
After 120 minutes

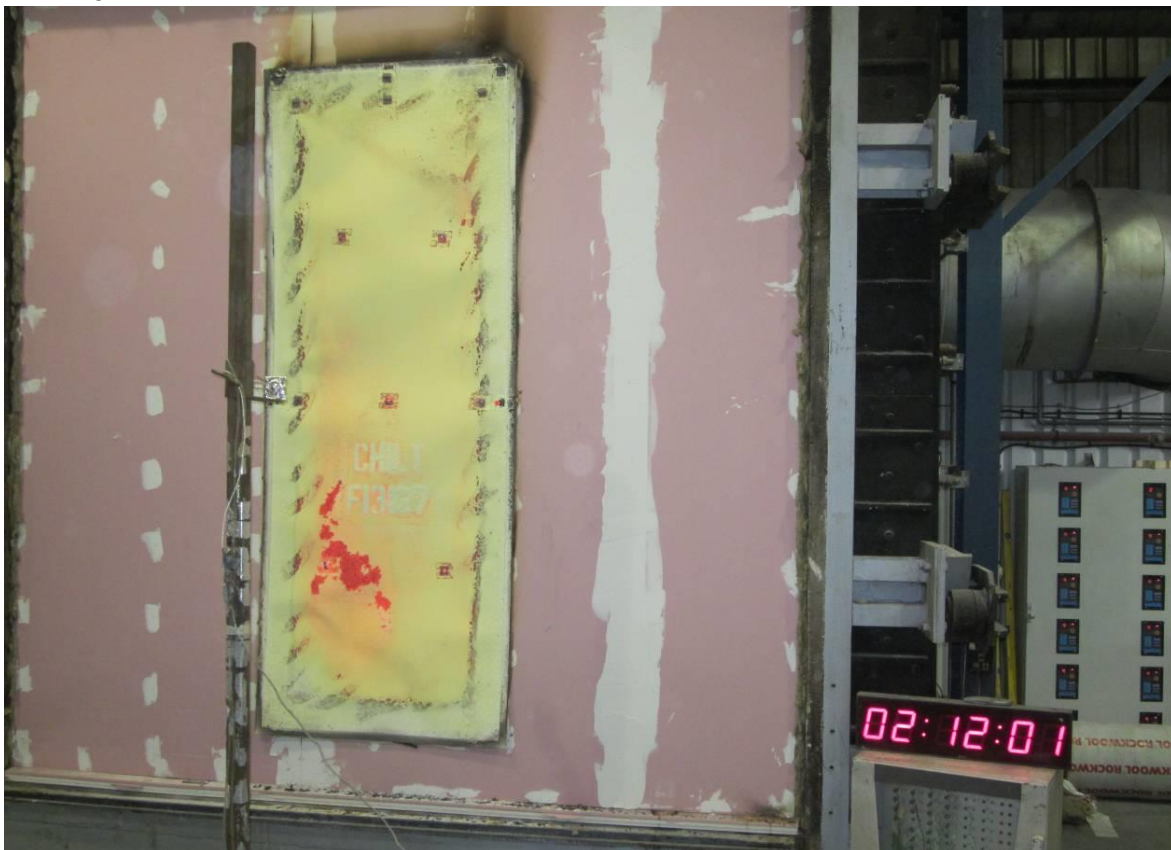
- 92.40 The leaf face is now glowing.
- 93.00 The leaf face is starting to ripple and distort.
- 102.30 The entire unexposed face is now glowing.
- 132.00 Test terminated

After 132 minutes
